CO DE IDENT. NO. 81205
NUMBER	D180-18488-1
TITLE:	DVANCED TECHNICAL DATA STUDY
	PHASE IV FINAL REPORT
QUENT REVISIONS	E DATE 1/29/25 FOR THE RELEASE DATE OF SUBSE- , SEE THE REVISIONS SHEET. FOR LIMITATIONS DISTRIBUTION AND USE OF INFORMATION CON- DOCUMENT, SEE THE LIMITATIONS SHEET.
MODEL	PREPARED UNDER:
SSUE NO	CONTRACT NO.
SSUE TO	X IR&D
	☐ OTHER
	PREPARED BY A.F. Byrne
	SUPERVISED BY D. R. Duren
	APPROVED BY Lothors

This document is the report of a test of microfilmed Fully Proceduralized Job Performance Aids (FPJPA's) compared to conventional hardcopy T.O.'s.

FPJPA's were written for the SRAM Missile Program Ground Support Equipment Air Conditioning Unit (ECU) and microfilmed. The standard T.O. for the same equipment was used for comparison purposes.

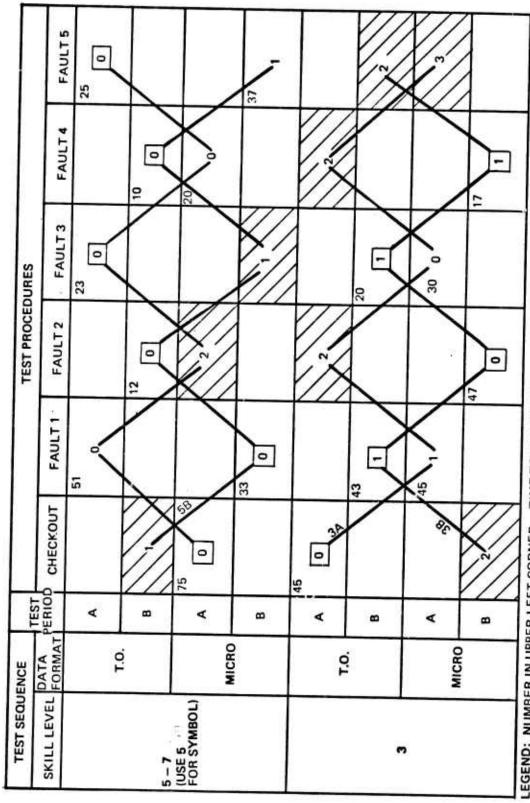
LEGEND: NUMBER IN UPPER LEFT CORNER - TIME TO COMPLETE PROCEDURE IN MINUTES NUMBER IN CENTER OF BLOCK - NUMBER OF ERRORS

Each block containing data represents a test sample. The number in the center of the block is the number of errors observed during the conduct of that test. The other number in the block is the time taken to accomplish the test sample. Diagonal shading on a block indicates the test subject failed to complete the test. A square around the number in the center of the block indicates that the test was completed quickest in comparing T.O. vs microfilm formats. The diagonal line between blocks is a trace of each test subject's activity. The following is an evaluation of the quality of the test subjects and test procedures developed from this summary of the data.

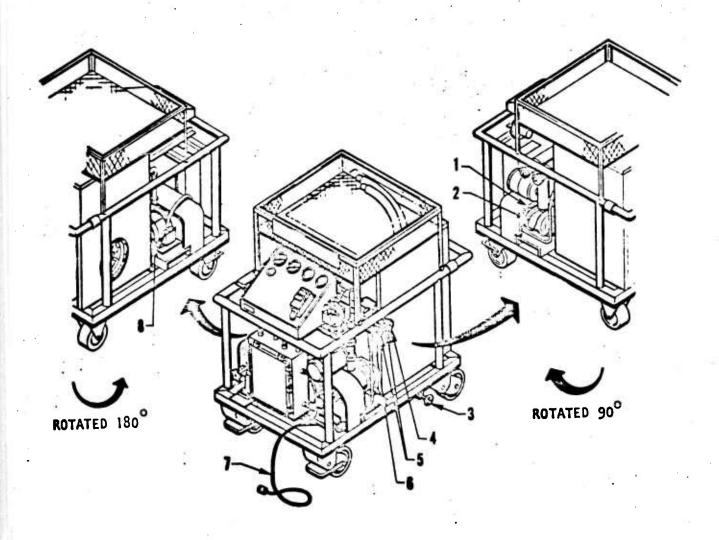
- 2. Rotate blower motor pulley (1) by hand to verify blower (2) and motor (8) turn freely without binding. If not, troubleshoot blower unit. Refer to AGE ECU Blower Unit Troubleshoot, Volume 2-6.
- 3. Remove dust caps (5) from SUPPLY pipe (4) and RETURN pipe (6).
- 4. Inspect supply pipe and return pipe for debris. If present, remove debris.
- 5. Open condensate drain valve (3).

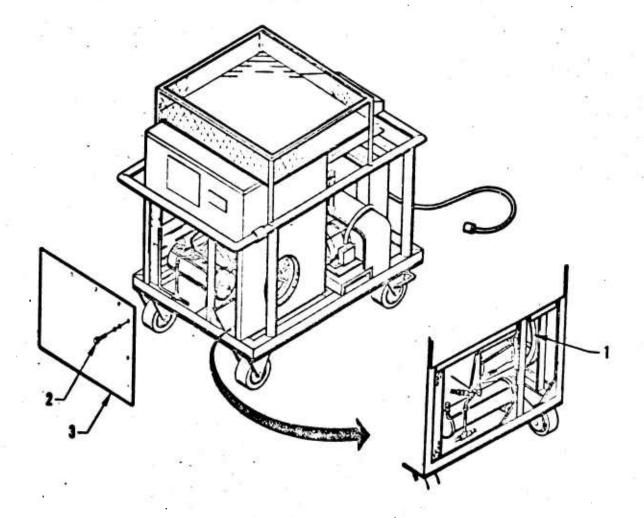
6. Remove screws and washers (2)
holding back cover (3) on cooling
unit and remove cover. Retain
screws and washers.

Verify power cable is disconnected from facility power before turning condenser fan by hand. Injury could result if AGE ECU were started. 7. Rotate condenser fan (1) by hand to verify fan turns freely without. binding. If not, troubleshoot condenser. Refer to AGE ECU Cooling Unit Condenser Troubleshoot, Volume 2-9.

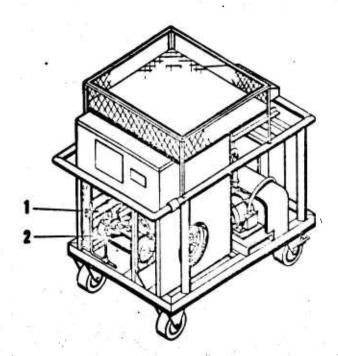
- 8. Inspect condenser fins (1) for debris. If present, remove debris. Refer to Condenser Cleaning, Volume 1-9, page 1-9- . After cleaning, continue with step 9.
- 9. Using light and mirror, as required, inspect all refrigerant lines (2) for secure mounting and no visual evidence of oil leakage. If mountings are loose or there is evidence of oil leakage, accomplish leak detection (refer to Refrigeration System Leak Detection, Volume 1-7, page 1-7—) and repair refrigerant lines and mountings. (Refer to Refrigeration System Piping Assembly Repair, Volume 1-7, page 1-7—.) After repair, return to step 1.

- 10. Observe RETURN TEMPERATURE gage
 (2) and SUPPLY TEMPERATURE gage
 (1) indicates close to ambient
 temperature. If not, remove temperature gage(s) and calibrate or
 replace. Refer to Remove and Install Temperature Gages, Volume
 1-5, page 1-5- and Calibration of
 Temperature Gages, Volume 1-5,
 page 1-5-.
- 11. Rotate handwheel (5) counterclockwise to limit.
- 12. Connect AGE ECU power cable (6) to facility power (3-phase, 208 volt, 60 Hz).

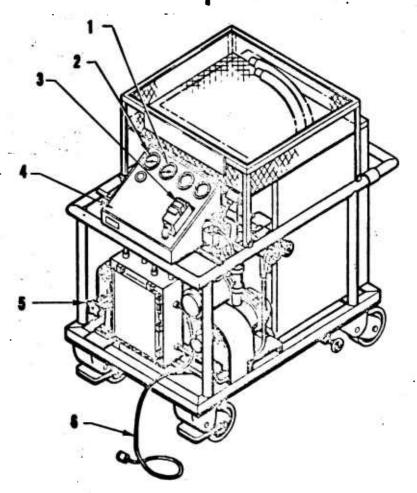
13. Press START switch (3) on control panel (4).

- Observe proper start, as indicated by operation of time meter, blower, fan and compressor. If not, press STOP switch (2). Go to Troubleshoot in this Volume for; Fail to Start, page 2-1-15, Automatic Shutdown, page 2-1-21, or Noisy and Rough Operation, page 2-1-26.
- 15. Operate AGE ECU for 0.2 to 0.3 hour, (12 to 18 minutes).
- 16. Observe elapsed time meter (1).

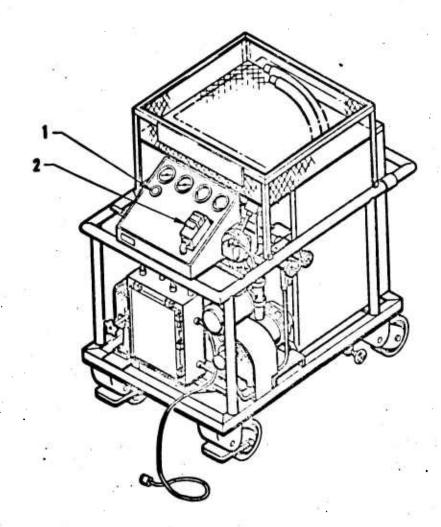
Reading should advance in time
 with operating time. If not, press
 STOP switch. Troubleshoot time meter. Refer to AGE ECU Instruments
 Troubleshoot, Volume 2-5.

- 17. Remove cover from refrigerator sight glass (2) and check that refrigerator sight glass is clear and free from bubbles. Replace sight glass cover.
- 18. Press STOP switch (1). If refrigerator sight glass was not clear and free from bubbles, troubleshoot cooling unit. Refer to AGE ECU Cooling Unit Troubleshoot, Volume 2-7.

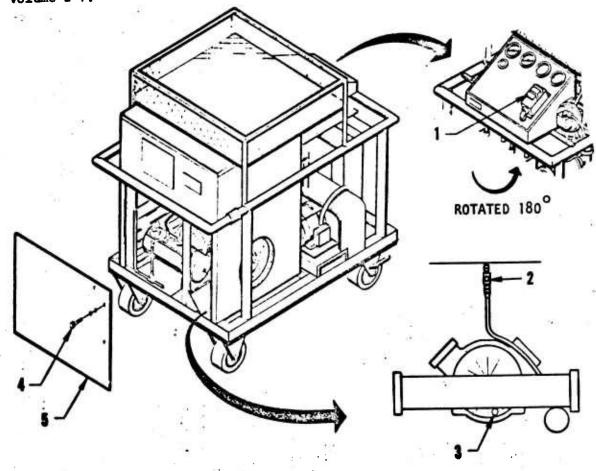
- 19. Check compressor oil sight glass
 (3) for oil level 1/8 inch or more
 above bottom of sight glass. If
 not, troubleshoot cooling unit.
 Refer to AGE ECU Cooling Unit
 Troubleshoot, Volume 2-7.
- 20. Place back cover (5) on cooling unit, and install washers and screws (4).

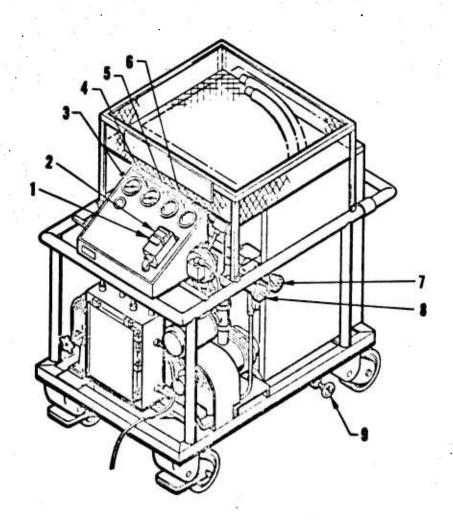
- 26. Operate unit 5 minutes or more.
- 27. Observe SUPPLY TEMPERATURE gage (4) reads less than 76°F. If not, troubleshoot cooling unit. Refer to AGE ECU Cooling Unit Troubleshoot, Volume 2-7.

- 28. Observe FLOW gage (5) indication exceeds 0.15 inch of water. If not, troubleshoot FLOW gage. Refer to AGE ECU Instruments Troubleshoot, Volume 2-5.

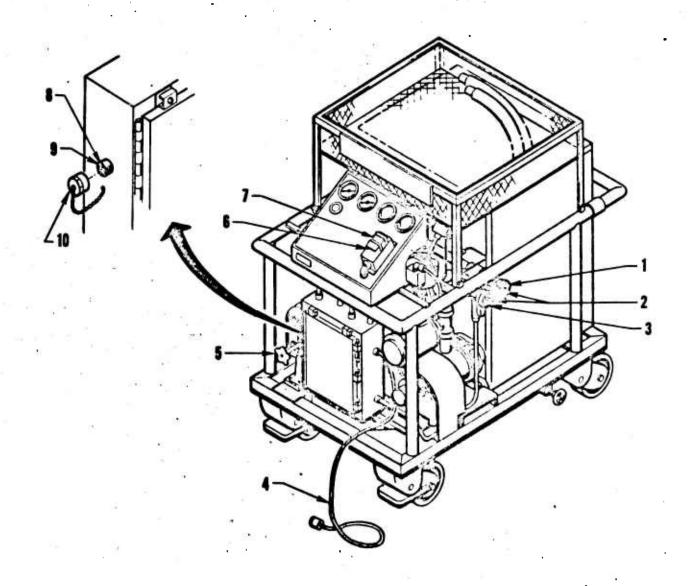
- 29. Remove dust cap (10) from test adapter set connector (8).
- 30. Set multimeter to read ohms in the 0 to 300 ohm range and zero meter. Refer to Test Equipment Operation, Volume 1-1.
- 31. Place multimeter leads on terminals A and B (9) of test adapter set connector (8) and read a left to right deflection. If not, press STOP switch (6). Go to step 33.
- 32. Hold leads in place and request
 assistant to press STOP switch
 (6). Read deflection right to left
 at 0.15 (±0.05) inch of water on
 flow gage. If deflection does not
 occur within flow limits, troubleshoot test adapter set alarm signal. Refer to AGE ECU Test Adapter
 Set Alarm Signal Troubleshoot,
 Volume 2-4.
- 33. Remove multimeter.
- 34. Disconnect AGE ECU power cable (4) from facility power.

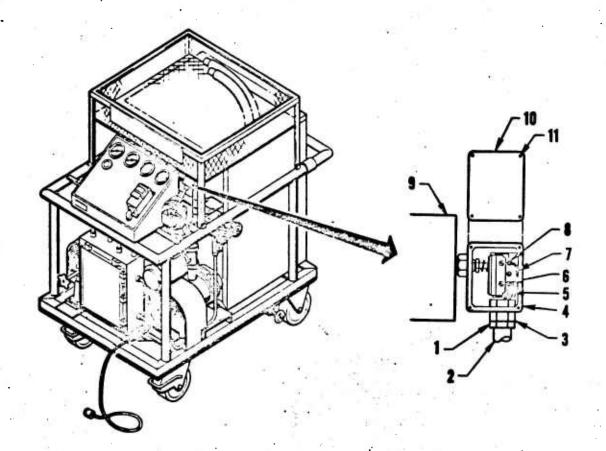
- 35. Remove cover (10) from temperature switch (4) by removing screws (11).
- 36. Disconnect wire 11A2O (5) and 11B2O (7) from temperature switch terminals (6) and (8). Tag wires to aid in reinstallation.
- 37. Remove conduit nut (1) from conduit connector (3).
- 38. Pull conduit (2) and wires (5) free of temperature switch.
- 39. Unscrew temperature switch (4) from tee bushing (9).

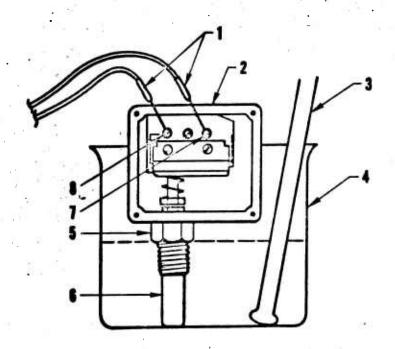
- 40. Fill a container (4) with hot tap water to a depth of 2 inches.
- 41. Place thermometer (3) in water and adjust water temperature to 100 to 105°F.
- 42. Insert temperature switch (2) into water.
- 43. Set multimeter to read ohms in the 0 to 300 ohm range and zero meter. Refer to Test Equipment Operation, Volume 1-1.
- 44. Place multimeter leads (1) on terminals COM (8) and NC (7) of temperature switch (2) and read zero on meter. If not, adjust temperature switch. Refer to Adjustment of Temperature Switch, Volume 1-4, page 1-4-. After adjustment, go to step 49.

- 45. Observe multimeter as water cools for a left to right meter deflection. If deflection occurs above 98°, adjust temperature switch.

After adjustment, go to step 49.
- 46. Cool water while observing multimeter. If a left to right meter deflection does not occur at or above 76°F, adjust temperature switch. Refer to Adjustment of Temperature Switch, Volume 1-4, page 1-4-. After adjustment, go to step 49.
- 47. Remove multimeter leads (1) from temperature switch (2).
- 48. Remove temperature switch (2) from container (4) and dry switch with clean dry cloth.

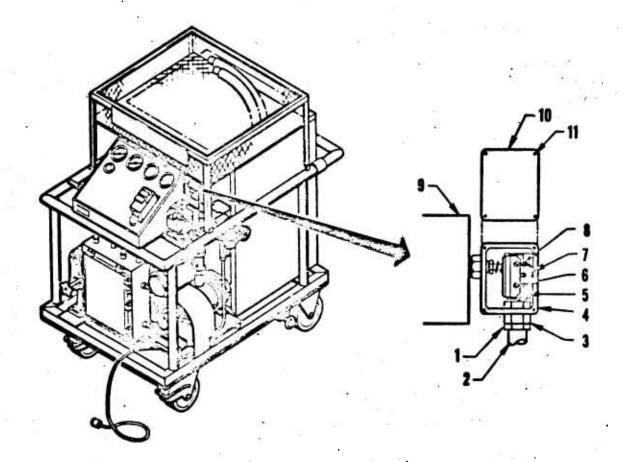
- 49. Apply packing to temperature switch (4) threads and screw temperature switch (4) into tee bushing (9).
- 50. Pull wires 11A20 (5) and 11B20 (7) into temperature switch (4).
- 51. Install conduit connector (3) into temperature switch (4) and tighten conduit nut (1).

- 52. Connect wire 11A2O (5) to terminal NC (6) and wire 11B2O (7) to terminal COM (8).
- 53. Place switch cover (10) on temperature switch (4) and install screws (11).

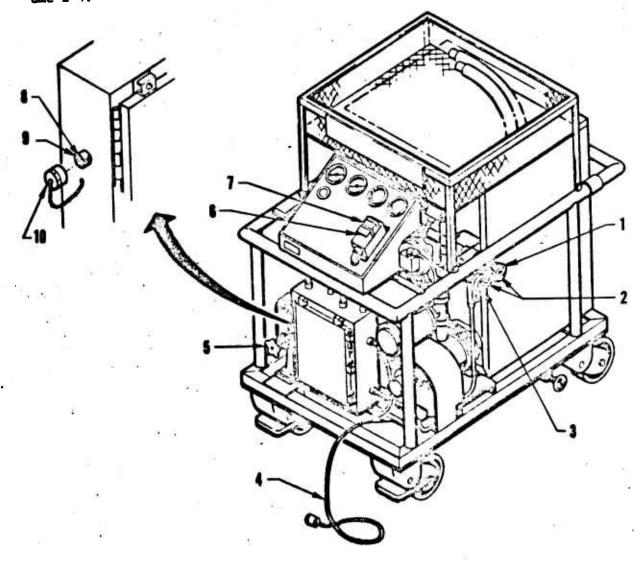
- 54. Connect AGE ECU power cable (4) to facility power.
- 55. Press START switch (7).
- 56. Set multimeter to read ohms in the 0 to 300 ohm range and zero meter. Refer to Test Equipment Operation, Volume 1-1.
- 57. Place multimeter leads on terminals A and B (9) of test adapter set connector (8) and read a left to right deflection. If not, press STOP switch (6) to troubleshoot test adapter set alarm signal. Refer to AGE ECU Test Adapter Set Alarm Signal Troubleshoot, Volume 2-4.
- 58. Hold leads in place and request assistant to press STOP switch (6). Read deflection right to left at 0.15 (±0.05) inch of water on flow gage. If deflection does not occur within flow limits, troubleshoot test adapter set alarm signal. Refer to AGE ECU Test Adapter Set Alarm Signal Troubleshoot, Volume 2-4.
- 59. Remove multimeter.
- 60. Install dust cap (10) on test adapter set connector (8).

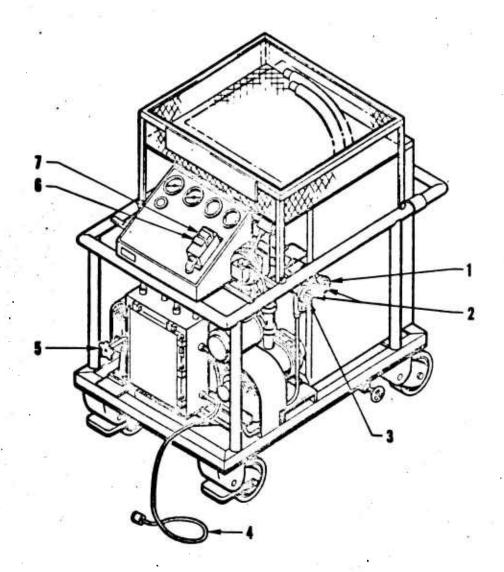
- 61. Press START switch (7).
- Observe blower speed increases. If blower speed does not increase, press stop switch. Go to Trouble-shoot Blower Unit, Volume 2-6.
- **63.** Rotate handwheel (5) counterclockwise to limit.

- 64. Press STOP switch (6).
- 65. Disconnect power cable (4) from facility power.
- 66. Install dust caps (2) on SUPPLY pipe (1) and RETURN pipe (3).

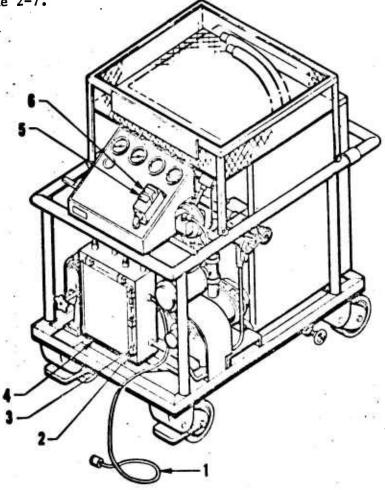
- Disconnect power cable (1) from facility power and reconnect.
- Press START switch (6). If proper start occurs, return to Checkout or test in progress.
- 3. Press STOP switch (5).
- 4. Check that facility power is on. If not, request assistance from facilities. After facility power is regained, return to Checkout or test in progress.
- Loosen screws (3) on electrical enclosure cover clamps (2).
- . 6. Move clamps (2) aside and open enclosure cover (4).

- 7. Press reset buttons (2) on motor starter (1) and press START switch (8). If proper start occurs go to step 11.
- 8. Remover cover (9) from electrical box (12) on cooling unit (11) by removing screws and lockwashers (10) and press reset button (13).
- 9. Press START switch (8). If proper start does not occur, press STOP switch (7) and disconnect power cable from facility power. Go to step 12.

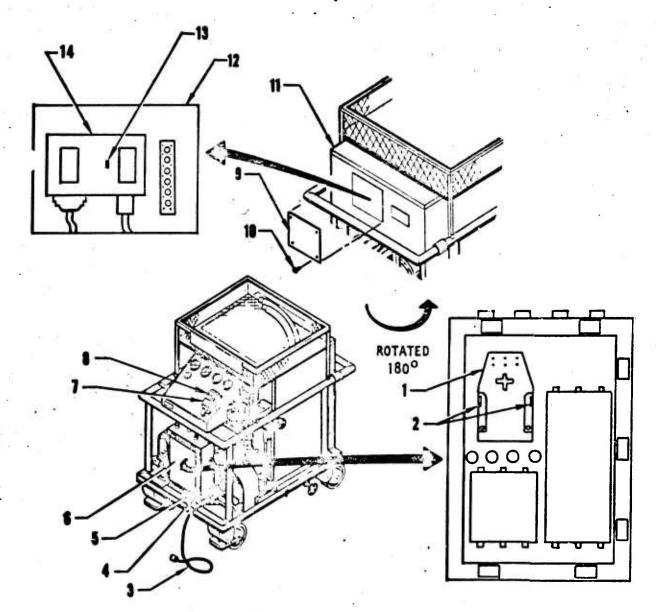
- 10. Place cover (9) on cooling unit (11) and install screws and lockwashers (10).
- 11. Close electrical enclosure cover (6), position clamps (4) to secure cover and tighten screws (5), Return to checkout or test in progress.
- 12. Set multimeter to read ohms in the 0 to 300 ohm range and zero meter. Refer to Test Equipment Operation, Volume 1-1.

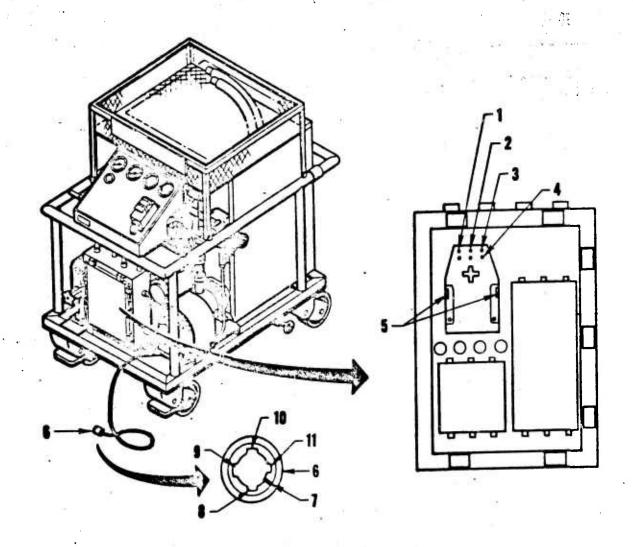
Verify power cable (6) is disconnected from facility power before making electrical checks. Injury from electrical shock could occur if power cable were connected.

Motor Starter (4)	Power Cable Plug (6)
L1 (1)	Pin (10) between arrow (7) and large pin (9)
L2 (2)	Pin (11) opposite large pin (9)
L3 (3)	Pin (8) remaining small pin.

If deflection is not observed in all checks, troubleshoot power line EMI and power cable circuit. Refer to AGE ECU Power Circuit Troubleshoot, Volume 2-3.

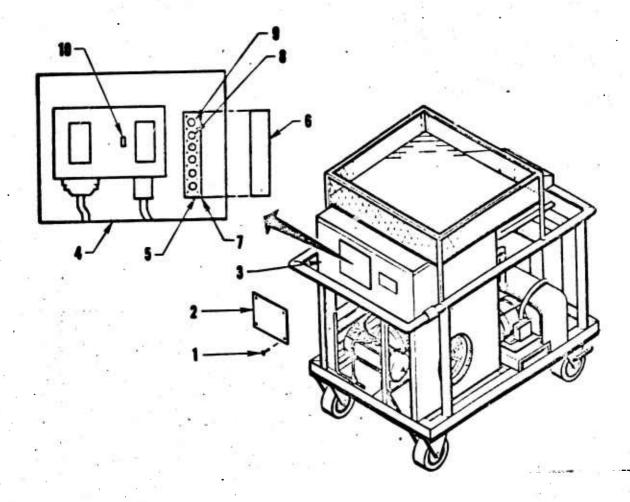
- Remove cover (6) from terminal board TB-1 (5) by pulling free of posts (7).
- 15. Place multimeter leads on terminals 5 (8) and 6 (9) of terminal board TB-1 (5). Read a left to right deflection. If no deflection is observed, troubleshoot pressure limit control. Refer to AGE ECU Cooling Unit Pressure Limit Control (Lear-Siegler) Troubleshoot, Volume 2-10.
- 16. Troubleshoot start circuit. Refer to AGE ECU Start Circuit (Lear-Siegler) Troubleshoot, Volume 2-2.

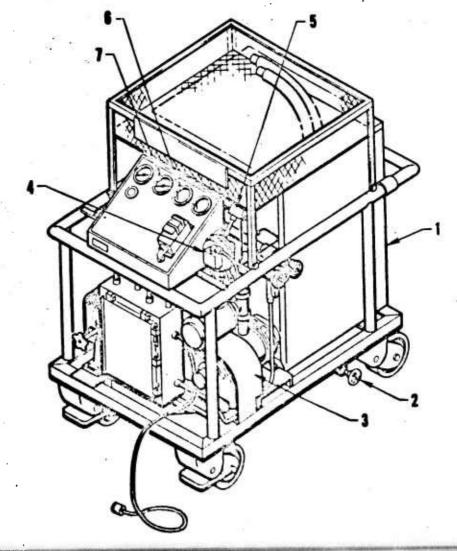
If blower unit (3) is not operating, troubleshoot blower unit. Refer to AGE ECU Blower Unit Troubleshoot, Volume 2-6.

- check flow gage (6) reading and supply air temperature gage (7) reading. If the flow gage (6) reading is above 0.15 inch of water and the supply air temperature gage (7) reading is below 76°F, troubleshoot test adapter set alarm signal. Refer to AGE ECU Test Adapter Set Alarm Signal Troubleshoot, Volume 2-4.
 - 3. If the flow gage (6) reads below 0.15 inch of water, go to step 4. If the supply air temperature gage (7) reads above 76°F, go to step 8.

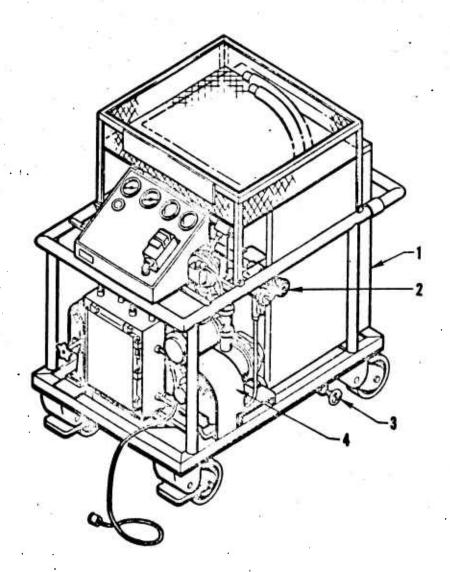
- 4. Check drain valve (3) open less than 1/4 turn. If open less than 1/4 turn, go to step 6.
- 5. Close drain valve (3), then open 1/4 turn. Read flow gage. If reading increases to over 0.15 inch of water, go to step 9.
- 6. Disconnect unit under test supply
 line from SUPPLY pipe (2). Read
 flow gage. If reading increases to
 over 0.15 inch of water, repair
 unit under test. Go to step 9.

- 7. Troubleshoot blower unit (4). Refer to AGE ECU Blower Unit (Lear-Siegler) Troubleshoot, Volume 2-6.
- Troubleshoot cooling unit (1). Refer to AGE ECU Cooling Unit (Lear-Siegler) Troubleshoot, Volume 2-7.
- Return to checkout or test in progress.

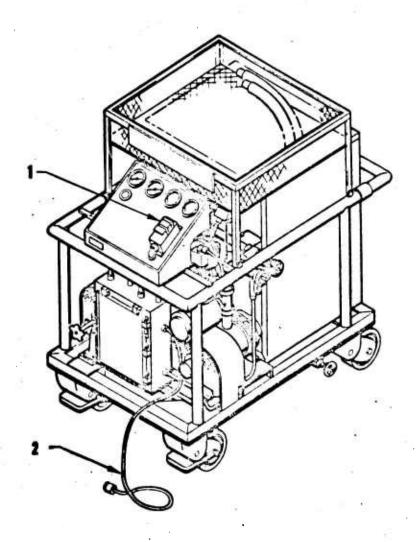
- Connect power cable (2) to facility power.
- 3. Wait about 5 minutes, then press START switch (1). If AGE ECU starts properly, go to step 8.

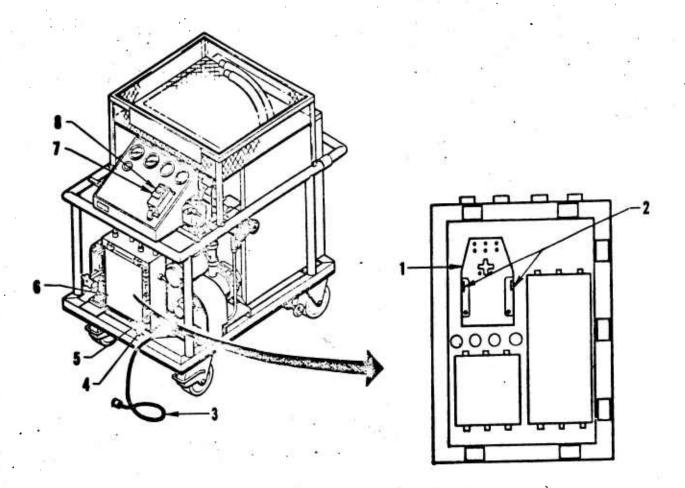
- Loosen screws (5) on electrical enclosure cover clamps (4).
- Move clamps (4) aside and open enclosure cover (6).
- 6. Press reset buttons (2) on motor
 starter (1). and press START
 switch (8).
- 7. If an attempt to start does not occur, press STOP switch. Go to step 10. If an attempt to start occurs but starter circuit breakers open to interrupt start, press STOP switch (7) and disconnect power cable (3). Go to step 15.

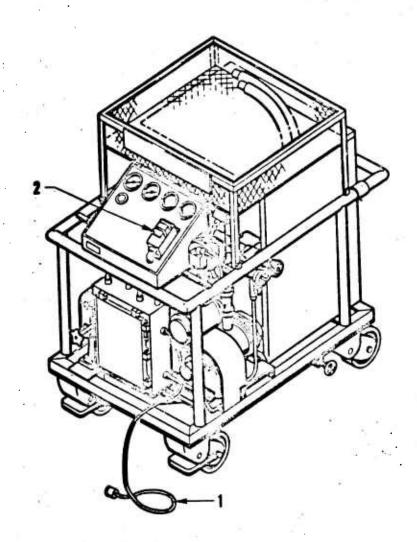
- 8. If AGE ECU starts properly, monitor AGE ECU operation for a period of 15 to 20 minutes. If shutdown does not recur, go to step 16.
- 9. If AGE ECU shutdown recurs, press STOP switch (2) and disconnect power cable (1) from facility power. Troubleshoot cooling unit, for HI-LOW pressure switch repeated cutout. Refer to AGE ECU Cooling Unit Troubleshoot, Volume 2-7.

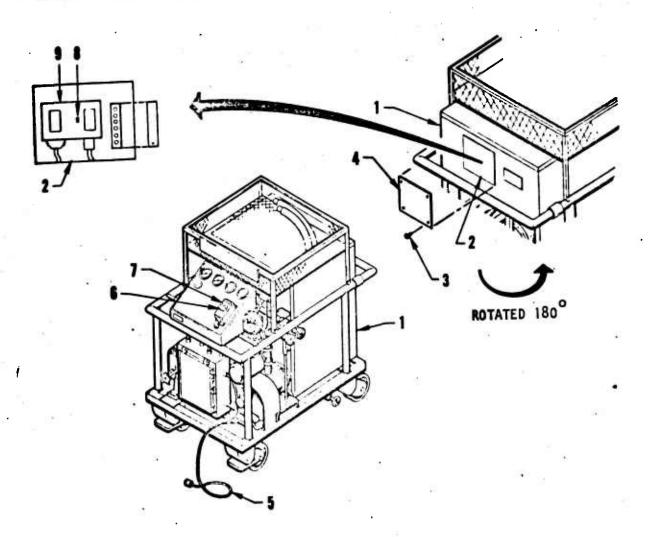
- 10. Remove cover (4) from electrical box (2) on cooling unit (1) by removing screws and lockwashers (3).
- (9) settings are: low pressure cutin 25 psig, low pressure cutout 5 psig, and high pressure cutout 250 psig. If settings are incorrect, disconnect power cable (5) from facility power and adjust settings. Refer to Pressure Limit Control Adjustment, Volume 1-10, page 1-10-. Go to step 16.
- 12. Press high pressure reset button
 (8) and press START switch (7). If
 start does not occur, press STOP
 switch (6) and disconnect power
 cable (5) from facility power.
 Troubleshoot pressure limit con-

- trol. Refer to AGE ECU Cooling Unit Pressure Limit Control (Lear-Sieglar) Troubleshoot, Volume 2-10.
- operation for a period of 15 to 20 minutes. If shutdown does not occur, place electrical box cover (4) on cooling unit (1) and install screws and washers (3). Go to step 16.
- 14. If AGE ECU shutdown recurs, press STOP switch (6) and disconnect power cable (5) from facility power. Troubleshoot cooling unit for pressure limit control high pressure switch repeated cutout. Refer to AGE ECU Cooling Unit Troubleshoot, Volume 2-7.

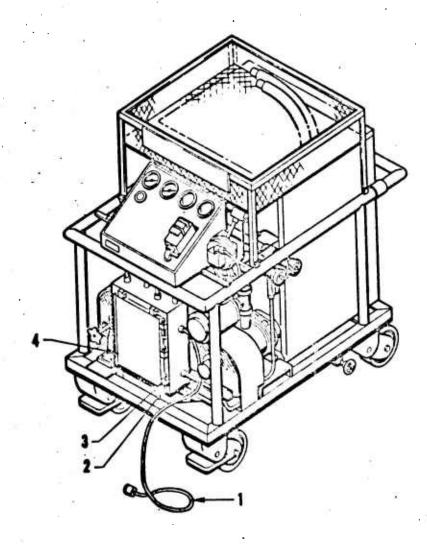
- 15. Review characteristics of attempted start. If blower and fan did not start, troubleshoot power circuit. Refer to AGE ECU Power Circuit Troubleshoot, Volume 2-3. If blower and fan started, but compressor did not, troubleshoot cooling unit. Refer to AGE ECU Cooling Unit Troubleshoot, Volume 2-7. If compressor and fan started but blower did not, troubleshoot blower unit. Refer to AGE ECU Blower Unit Troubleshoot, Volume 2-6.
- 16. Close electrical enclosure cover (4). Position clamps (2) to secure cover and tighten screws (3).
- 17. Return to checkout or test in progress.

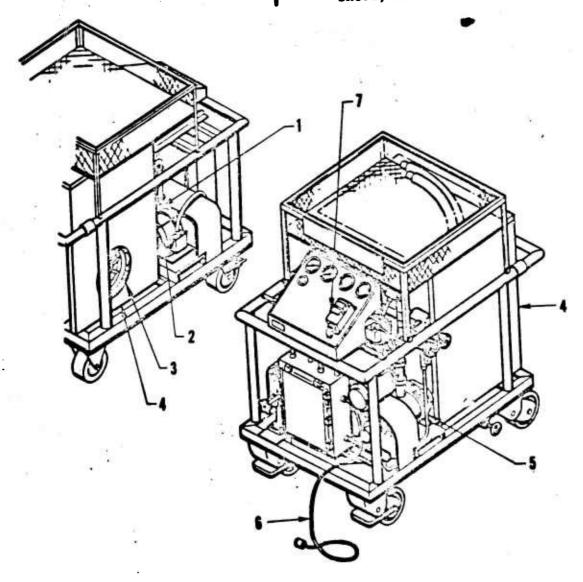
- 1. Press STOP switch (7).
- Disconnect power cable from facility power (6).

Note the location and characteris-3. tic of the noise. If noise and/or vibration was coming from the blower (5), blower motor (2) or blower varidrive (1), troubleshoot the blower unit. Refer to AGE ECU Blower Unit Troubleshoot, Volume 2-6. If noise and/or vibration was coming from the cooling unit condenser fan (3) troubleshoot the cooling unit condenser fan. Refer to AGE ECU Cooling Unit Condenser (Lear-Siegler) Troubleshoot, Volume 2-9. If the noise and/or vibration was coming from the cooling unit, but not the condenser fan (3), troubleshoot the cooling unit (4). Refer to AGE ECU Cooling Unit (Lear-Siegler) Troubleshoot, Volume 2-7.

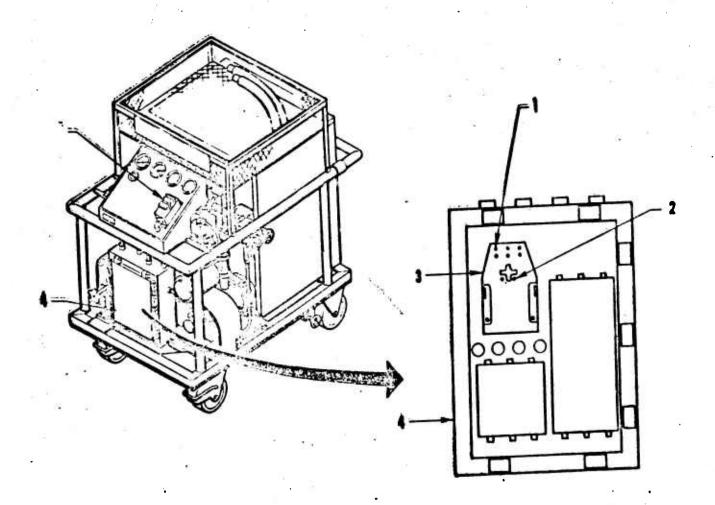
- 1. Inspect wiring in electrical enclosure (4) for security of attachment and condition of wire and insulation. If any wires are loose or damaged, reinstall or replace.

Refer to Repair of Wiring, Volume 1-2, page 1-2-. Go to step 26.
- Place multimeter leads on L1 (1) and 3 (2) of motor starter (3).

Request assistant to press START switch (5). Read left to right deflection and request assistant to release START switch. If deflection is not observed, go to step

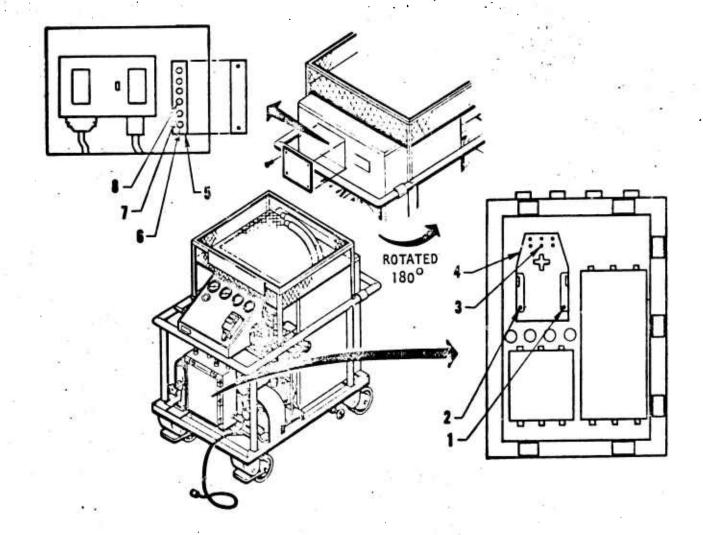
Motor	Terminal Board
Starter (4)	TB-1 (5)
T1 (2)	1 (6)
T2 (3)	2 (7)
T3 (1)	3 (8)

If deflection is observed in each check, replace motor starter (4).
Refer to Remove and Install Motor Starter, Volume 1-2, page 1-2-.
If deflection is not observed in all checks, troubleshoot power line EMI filter and input harness.
Refer to AGE ECU Power Circuit Troubleshoot, Volume 2-3.

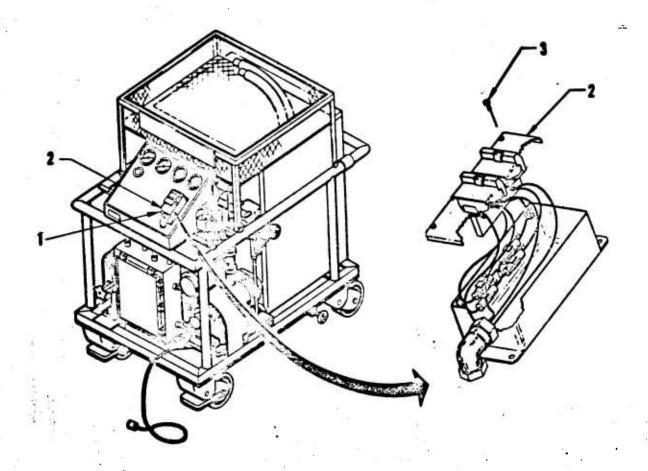
- 4. Remove four screws (3) from START-STOP switch cover (2) and lift cover, taking care not to damage gasket.
- 5. Observe START-STOP switch (1) for burned areas, or the odor of burned insulation. If this condition exists, replace START-STOP switch. Refer to Remove and Install START-STOP Switch, Volume 1-2, page 1-2-. Go to step 23.

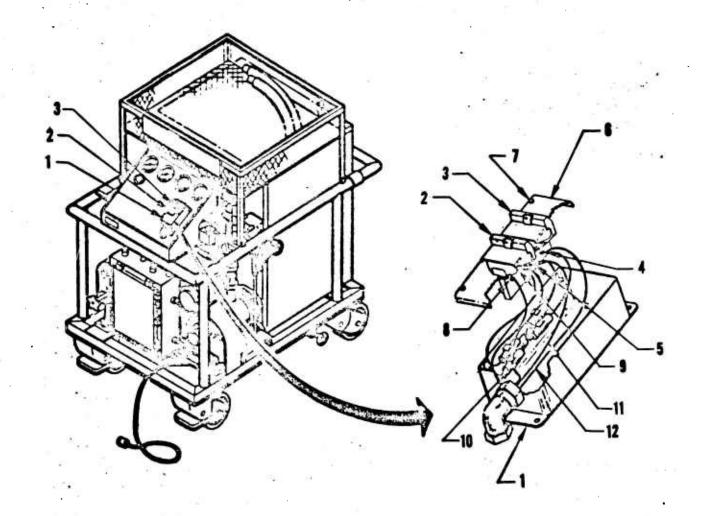
- 6. Place one multimeter lead on STOP switch (2) NC connector (9) (attached to C2 capacitor) and other multimeter lead on START switch (3) NO connector (5) (attached to R1 resistor). Read left to right meter deflection. If no deflection, replace START-STOP switch (1). Refer to Remove and Install START-STOP Switch, Volume 1-2, page 1-2-. Go to step 23.
- 7. Move multimeter lead from START switch NO connector (5) (attached to R1 resistor) to START switch NO connector (4) (attached to C1 capacitor). Read no meter deflection. If deflection is observed, replace START-STOP switch (1). Refer to Remove and Install START-STOP Switch, Volume 1-2, page 1-2-. Go to step 23.
- 8. Press START switch (3). Read left to right deflection. If no deflection, replace START-STOP switch (1). Refer to Remove and Install START-STOP Switch, Volume 1-2, page 1-2-.

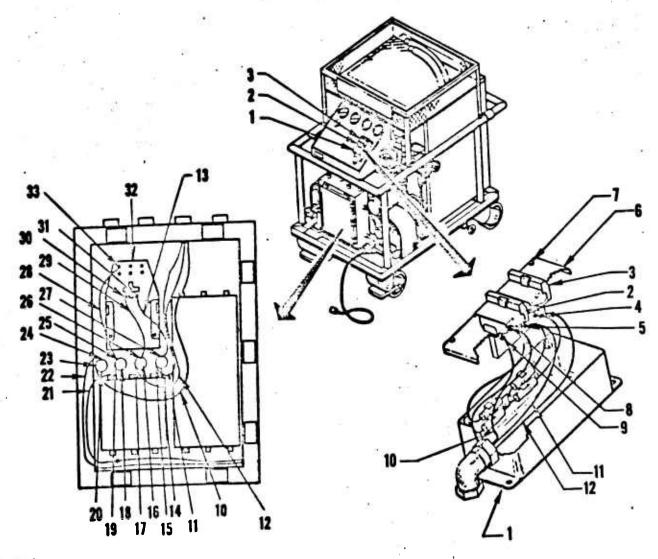
- 12. Move multimeter lead from solder connection (15) (wire 7B22 to inductor) to solder connection (27) (wire 7C22 to inductor). If left to right meter deflection is observed, replace wire 7C22 (13). Refer to Repair of Wiring, Volume 1-2, page 1-2-. If meter deflection is not observed, replace inductor (14). Refer to Remove and Install Inductors, Volume 1-2, page 1-2-.

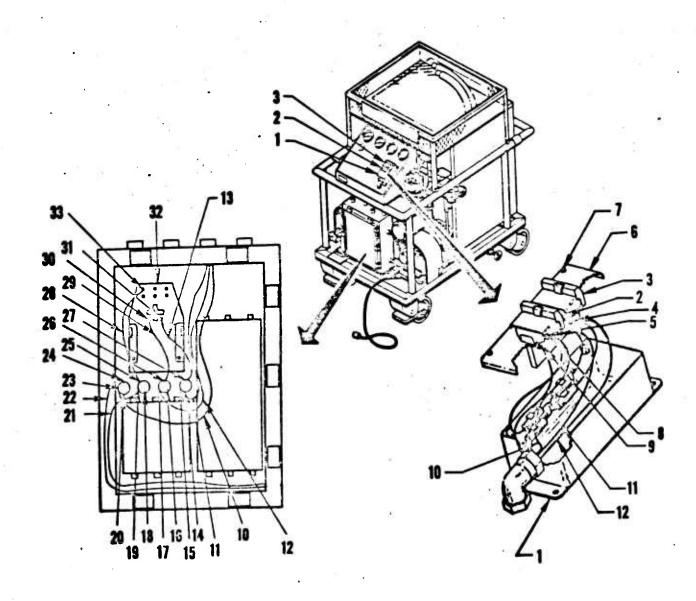
TROUBLESHOOT START CIRCUIT

- 14. Move multimeter lead from 2 (30)
 of motor starter (32) to solder
 connection (17) (wire 6B22 to inductor). Read left to right meter
 deflection. If no deflection, replace wire 6B22 (12). Refer to Repair of Wiring, Volume 1-2, page
 1-2-. Go to step 23.
- connection (17) (wire 6B22 to inductor) to solder connection (26) (wire 6C22 to inductor). If left to right meter deflection is observed, replace wire 6C22 (29). Refer to Repair of Wiring, Volume 1-2, page 1-2-. If meter deflection is not observed, replace inductor (16). Refer to Remove and Install Inductors, Volume 1-2, page 1-2-.
- 16. Go to step 23.

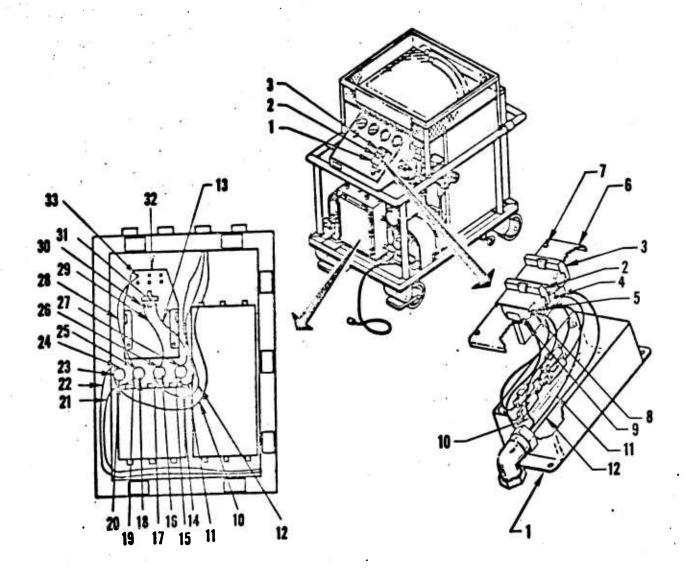
TROUBLESHOOT START CIRCUIT

- 19. With the aid of assistant, move multimeter lead from STOP switch NC connector (9) (attached to C2 capacitor) to solder connection (23) (wire 7D22 to inductor). Read left to right meter deflection. If no deflection, replace wire 7D22 (10). Refer to Repair or Wiring, Volume 1-2, page 1-2-. Go to step 23.
- 20. Move multimeter lead from solder connection (23) (wire 7D22 to inductor) to solder connection (24) (wire P3B22 to inductor). If left to right meter deflection is observed, replace wire P3B22 (22). Refer to Repair of Wiring, Volume 1-2, page 1-2-. Go to step 23.

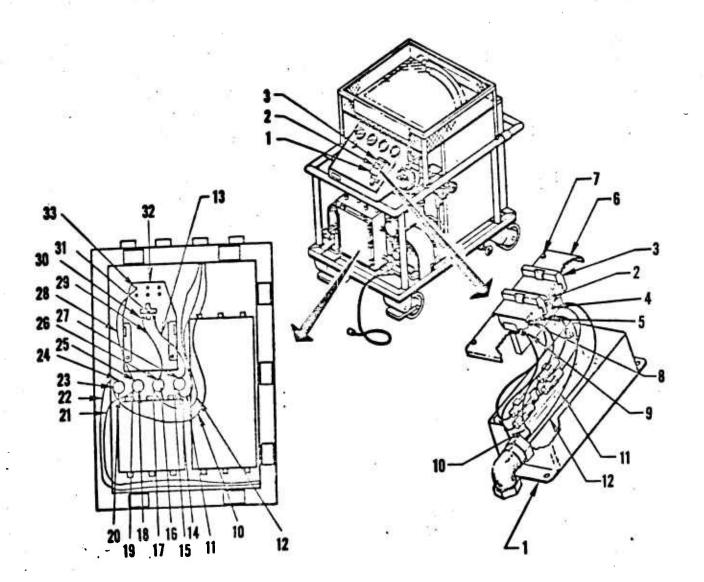
TPOUBLESHOOT START CIRCUIT

- 21. Move multimeter lead from terminal L1 (33) of motor starter (32) to solder connection (25) (wire 8B22 to inductor). Read left to right meter deflection. If no deflection, replace wire 8B22 (28). Refer to Repair of Wiring, Volume 1-2, page 1-2-. Go to step 23.
- 22. Move multimeter to solder connection (19) (wire P1B22 to inductor). If left to right meter deflection is observed, replace wire P1B22 (21). Refer to Repair of Wiring. Volume 1-2, page 1-2- If meter deflection is not observed, replace inductor (18). Refer to Remove and Install Inductors, Volume 1-2, page 1-2.

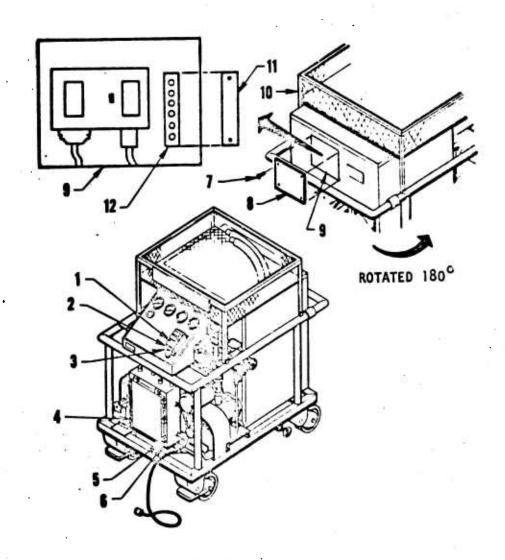
TROUBLESHOOT START CIRCUIT

- 23. Place cover (1) with gasket in place, on START-STOP switch (2) and install four screws (3).
- 24. Place terminal board cover (11) on terminal board (12).
- 25. Place electrical box cover (8) on cooling unit (10) and install screws and washers (7).
- Close electrical enclosure cover(4). Position clamps (5) to securecover, and tighten screws (6).
- 27. Return to checkout or test in progress.

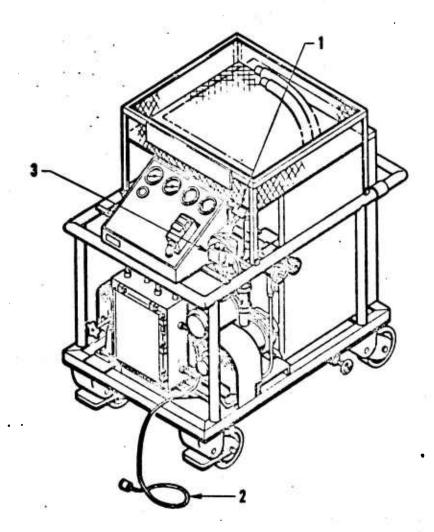
- 2. Review the trouble symptoms which were evident at time the Test
 Adapter Set Alarm Signal was identified as the faulty subsystem.
- 3. If the alarm signal did not activate when loss of air flow occurred, the pressure switch (3) failed to open circuit. Adjust or replace pressure switch. Refer to Adjustment of Pressure Switch, Volume 1-4, page 1-4-, and Remove and Install Pressure Switch, Volume 1-4, page 1-4-. If the fault remains, go to step 9.

4. If the alarm signal did not activate with indicated cooling air temperature above 98°F, the temperature switch (1) failed to open circuit. Calibrate or replace temperature switch. Refer to Calibration of Temperature Switch, Volume 1-4, page 1-4-, and Remove and Install Temperature Switch, Volume 1-4, page 1-4-. If the fault remains, go to step 9.

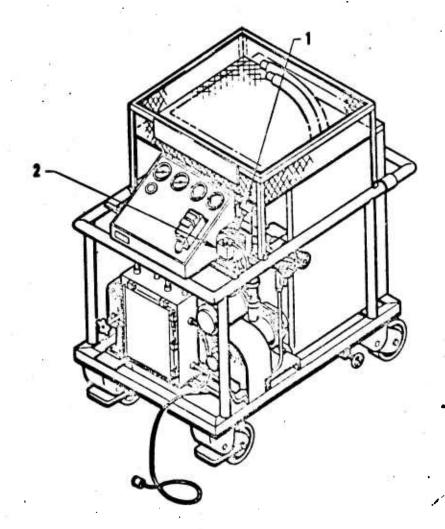
TROUBLESHOOT TEST ADAPTER SET ALARM SIGNAL

- 5. If the alarm signal activated with an indicated air flow above 0.15 inch of water and an air temperature below 76°F, check out temperature switch (1). Refer to AGE ECU Checkout, Volume 2-1, pages 2-1-11 through 2-1-14.
- 6. If, in step 5, the temperature switch (1) was found to be at fault, calibrate or replace the temperature switch. Refer to Calibration of Temperature Switch, Volume 1-4, page 1-4-, and Remove and Install Temperature Switch, Volume 1-4, page 1-4-.
- 7. If, in step 5, the temperature switch was found to be good, check pressure switch (2) and adjust or replace as required. Refer to Adjustment of Pressure Switch, Volume 1-4, page 1-4-, and Remove and Install Pressure Switch, Volume 1-4, page 1-4-
- 8. If, in steps 5 through 7, both the pressure switch and the temperature switch were found to be good, the connecting wiring or tubing is at fault. Go to step 9.

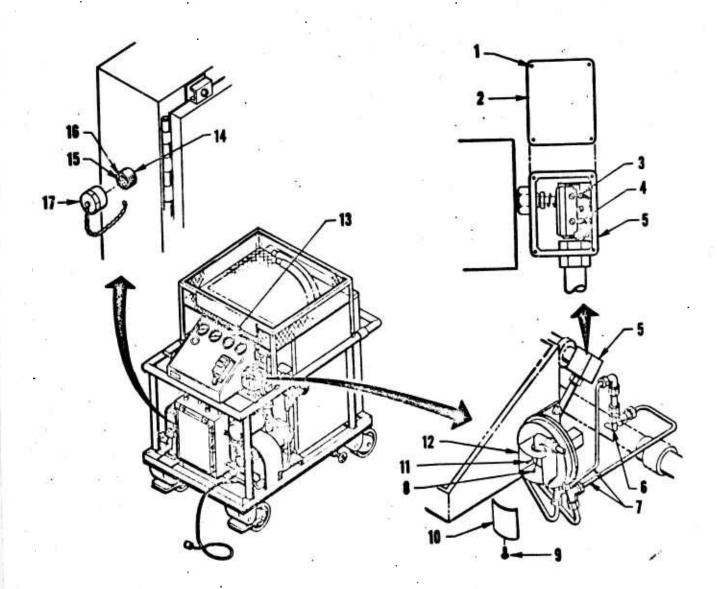
TRC LESHOOT TEST ADAPTER SET ALARM SIGNAL

- Remove cover (2) from temperature
 switch (5) by removing screws (1).
- 10. Remove cover (10) from pressure switch (12) by removing screw (9).
- 11. Remove dust cap (17) from test adapter set connector (14).
- 12. Set multimeter to read ohms in the 0 to 300 ohm range and zero meter. Refer to Test Equipment Operation, Volume 1-1.

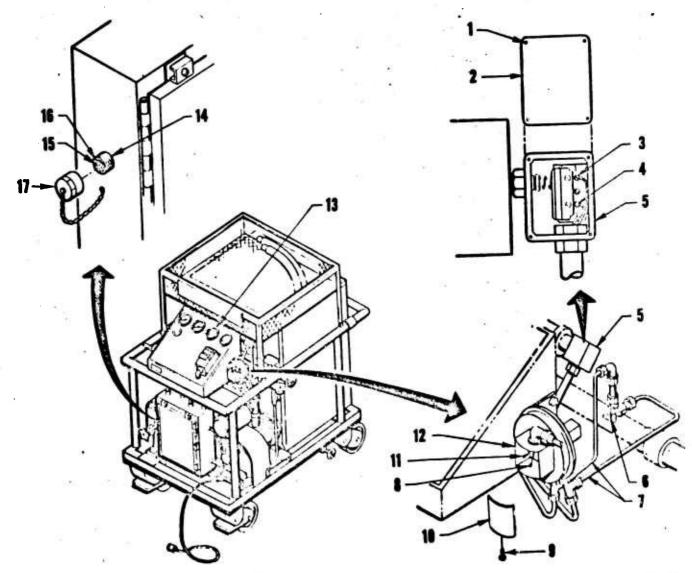
TROUBLESHOOT TEST ADAPTER SET ALARM SIGNAL

- minal A (16) of test adapter set connector (14) and other on temperature switch terminal COM (3).

If not, wire 11B20 is open. Repair connection at test adapter set connector or temperature switch terminals, or replace wire. Refer to Repair of Wiring, Volume 1-5.

If not, wire 12A2O is open. Repair connection at test adapter set connector or pressure switch terminals, or replace wire. Refer to Repair of Wiring, Volume 1-5. Go to step 19.
- perature switch terminal NC (4)
 and other on pressure switch terminal NO (8). Read a left to right
 deflection. If not, wire 11A20 is
 open. Repair connection at temperature switch or pressure switch,
 terminals, or replace wire. Refer
 to Repair of Wiring, Volume 1-5.
 Go to step 19.

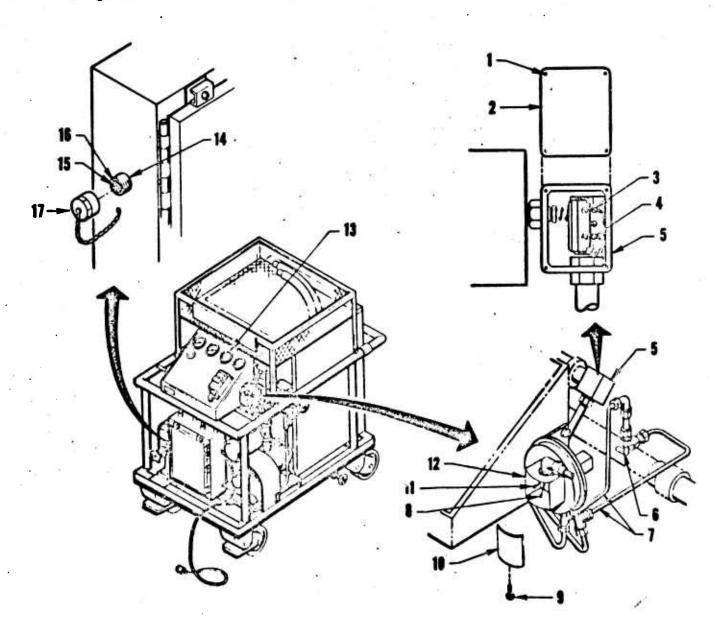
TROUBLESHOOT TEST ADAPTER SET ALARM

- 16. If the alarm signal activated with a significant air flow being delivered, but an indication of no air flow on the FLOW gage (13), the impact tube (6) is misaligned or obstructed, or the connecting tubing (7) is obstructed.
- 17. Disconnect tubing (7) at pressure switch (12) and blow through tubing to determine that it is clear of obstructions. If tubing is clear, check impact tube (6) alignment. Refer to Cleaning and

- Repair of Tubing, Volume 1-5, page 1-5-, and Alignment of Impact Tube, Volume 1-4, page 1-4-.
- 18. Connect tubing (7) to pressure switch (12).
- 19. Install cover (2) on temperature switch (5) with screws (1).
- 20. Install cover (10) on pressure switch (12) with screw (9).
- 21. Install dust cap (17) on test adapter set connector (14).

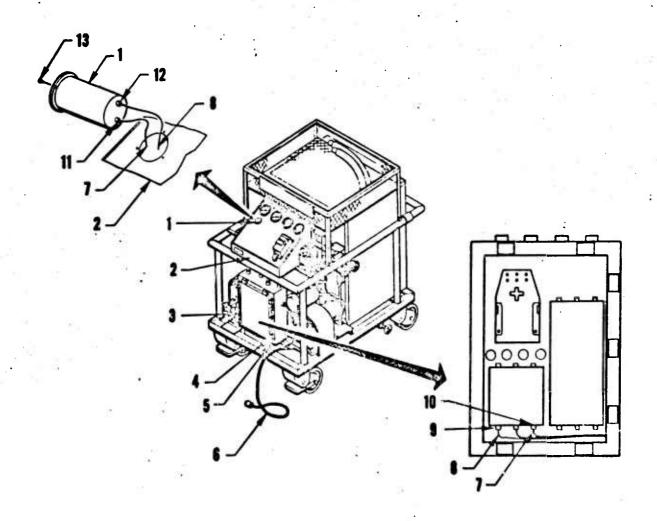
- Disconnect power cable (6) from facility power.
- 2. Loosen screws (4) on electrical enclosure cover clamps (5).
- Move clamps aside and open electrical enclosure cover (3).
- 4. Remove three screws (13) from time meter (1).
- 5. Lift time meter (1) from ECU control panel (2), to expose electrical connectors (11) and (12).

- 6. Set multimeter to read ohms in the 0 to 300 ohm range and zero meter. Refer to Test Equipment Operation, Volume 1-1, page 1-1-
- 7. Place one multimeter lead on power EMI filter terminal 1 (10) and other multimeter lead on time meter terminal (12) to which wire 8C14 (7) is attached. Read left to right meter deflection. If no deflection, replace wire 8C14 (7). Refer to Repair of Wiring, Volume 1-5, page 1-5-. Go to step 9.

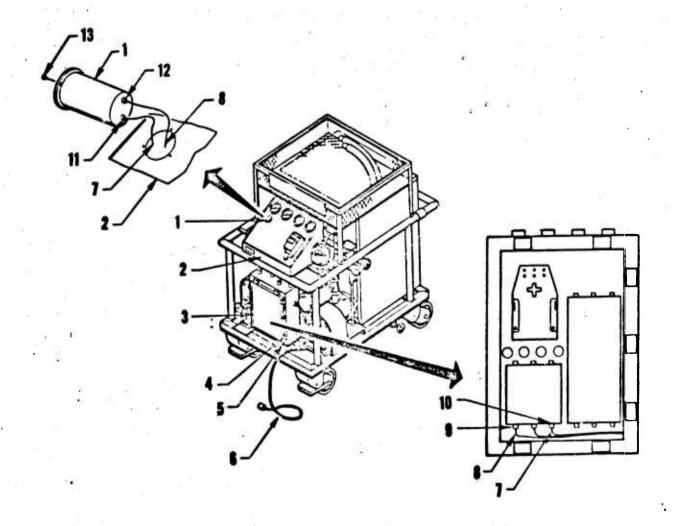
TROUBLESHOOT ELAPSED TIME METER

- 8. Place one multimeter lead on power EMI filter terminal 3 (9) and other multimeter lead on time meter terminal (11) to which wire 10C14 (8) is attached. If left to right meter deflection is observed, replace time meter (1). Refer to Remove and Install Time Meter, Volume 1-5, page 1-5-. If deflection is not observed, replace wire 10C14 (8). Refer to Repair of Wiring, Volume 1-5, page 1-5-.
- 9. Place time meter (1) in ECU control panel (2) and install three screws (13).
- Close electrical enclosure cover
 (3), position clamps (5) to secure
 cover, and tighten screws (4).
- 11. Return to checkout AGE ECU, step
 11, if checkout is in progress, or
 checkout time meter per steps 11
 through 15 of checkout AGE ECU.

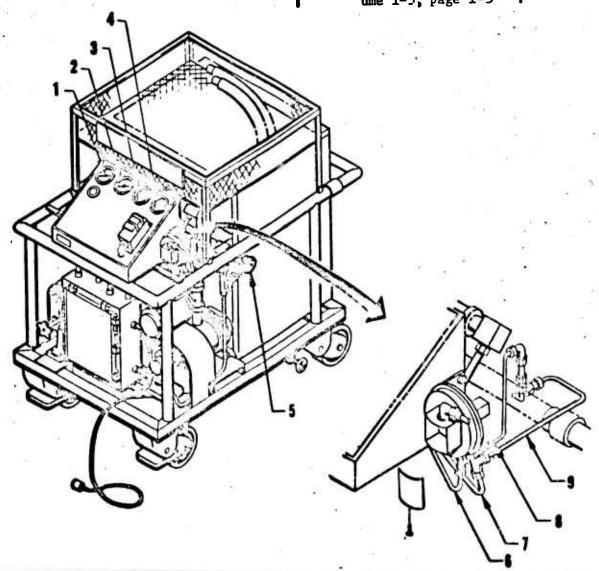
TROUBLESHOOT AIR TEMPERATURE GAGES, FLOW GAGE AND PRESSURE GAGE

- If either the SUPPLY AIR TEMPERATURE gage (2) or the RETURN AIR TEMPERATURE gage (1) does not read the ambient temperature when the AGE ECU is not operating and is at ambient temperature, remove the gage(s) and calibrate or replace.

Refer to Remove and Replace Temperature gages, Volume 1-5, page 1-5, and Calibration of Temperature Gages, Volume 1-5, page 1-5.
- 2. If FLOW gage (3) and PRESSURE gage (4) readings do not change when AGE ECU is started but both PRESSURE gage and FLOW gage readings increase when hand is placed over SUPPLY pipe (5), static pressure tube (9) or (7) is plugged. Inspect tube (9) or (7) and clean or replace. Refer to Repair of Instrument Tubing, Volume 1-5, page 1-5-
- 3. If FLOW gage (3) and PRESSURE gage (4) readings do not change when AGE ECU is started but FLOW gage reading drops below zero and PRESSURE gage reading increases when hand is placed over SUPPLY pipe, impact pressure tube (8) or (6) is plugged. Inspect tube (8) or (6) and clean or replace. Refer to Repair of Instrument Tubing, Volume 1-5, page 1-5-

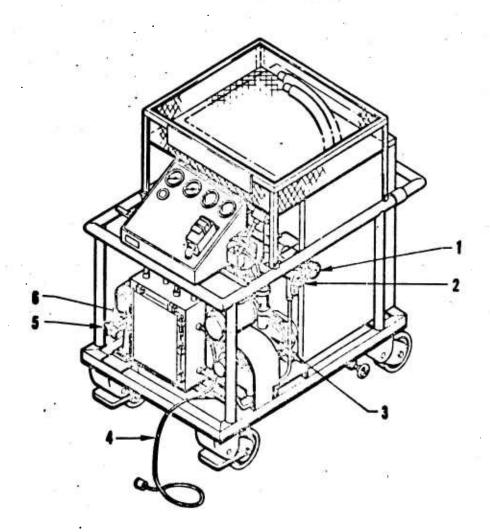
- 1. Disconnect power cable (4) from facility power, if connected.
- 2. Review the trouble symptoms which were evident at time of AGE ECU shutdown.
- 3. If blower (3) and blower motor (6) were operating with excessive noise and the air flow was out of the RETURN pipe (2) instead of out of the SUPPLY pipe (1), the motor was running in reverse. Go to step 9.
- 4. If blower motor (6) has been identified as cause of automatic shutdown, go to step 14.

- 5. If blower motor (6) was rough and noisy, go to step 24.
- If blower (3) was rough and noisy, go to step 26.
- 7. If variable drive (5) was rough and noisy, and/or speed adjustment was sluggish or impossible go to step 28.
- 8. If inadequate air flow was indicated with blower (3), blower motor (6) and variable drive (5) functioning properly, go to step 33.

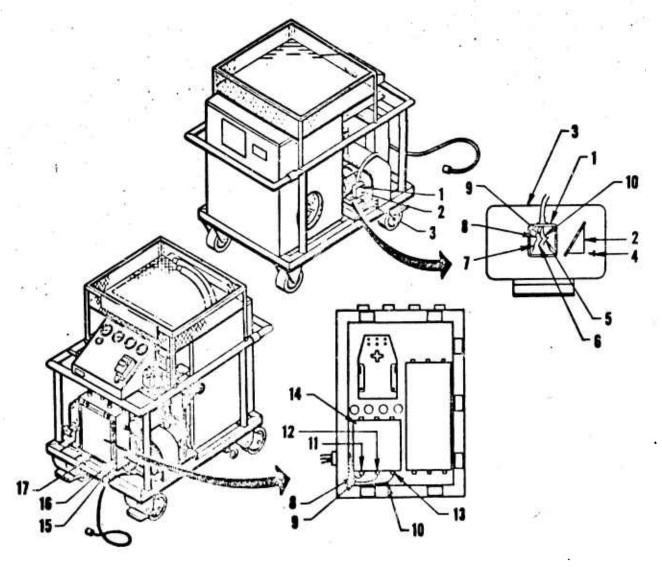
- Remove cover (2) from conduit box
 (1) on blower motor (3) by removing screws (4).
- 10. Loosen screws (15) on electrical enclosure cover clamps (16).
- 11. Move clamps aside and open electrical enclosure cover (17).

Wire	Bl ower Motor	Power EMI Filter
3B14 (8)	C (7)	3 (11)
2B14 (9)	B (6)	2 (12)
1B14 (10)	A (5)	1 (13)

13. If a connection at the motor is incorrect, rewire. Refer to Repair of Wiring, Volume 1-6, page 1-6. If a connection at the power EMI filter is incorrect, move wires in error to correct terminals. Go to steps 22 and 23.
